YOUR ONESURVEY  
**HOME REPORT**

15a Bellfield Park  
Inverness  
IV2 4TA

# Single Survey

<b>Date of Inspection</b>	09/07/2024
---------------------------	------------

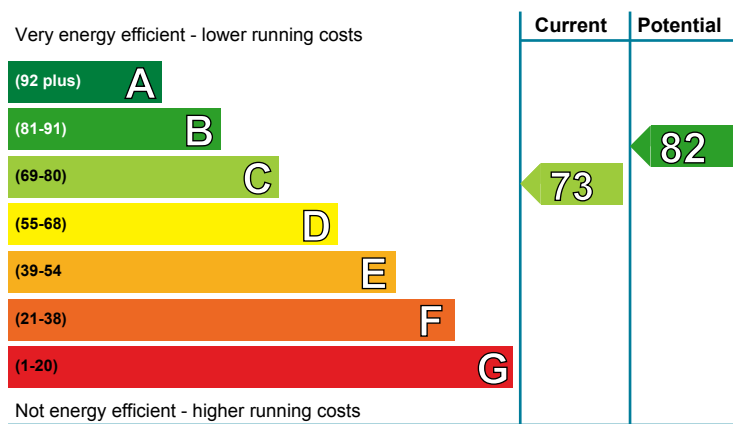
## Energy Efficiency Rating

This graph shows the current efficiency of your home, taking into account both energy efficiency and fuel costs. The higher this rating, the lower your fuel bills are likely to be.

Your current rating is **band C (73)**. The average rating for EPCs in Scotland is **band D (61)**.

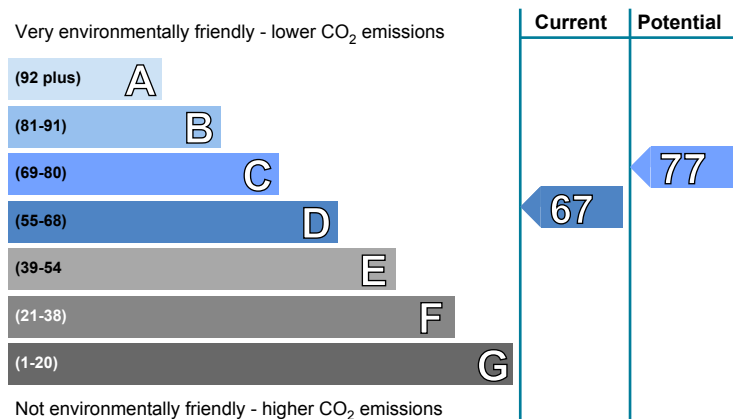
## Environmental Impact (CO<sub>2</sub>) Rating

This graph shows the effect of your home on the environment in terms of carbon dioxide (CO<sub>2</sub>) emissions. The higher the rating, the less impact it has on the environment.
