YOUR ONESURVEY
HOME REPORT

Red Kite Cottage
Knockfarrel, Dingwall
IV15 9TQ

Single Survey

Prepared by	James Burns, BSc MRICS Inverness - Allied Surveyors Scotland Ltd
--------------------	---

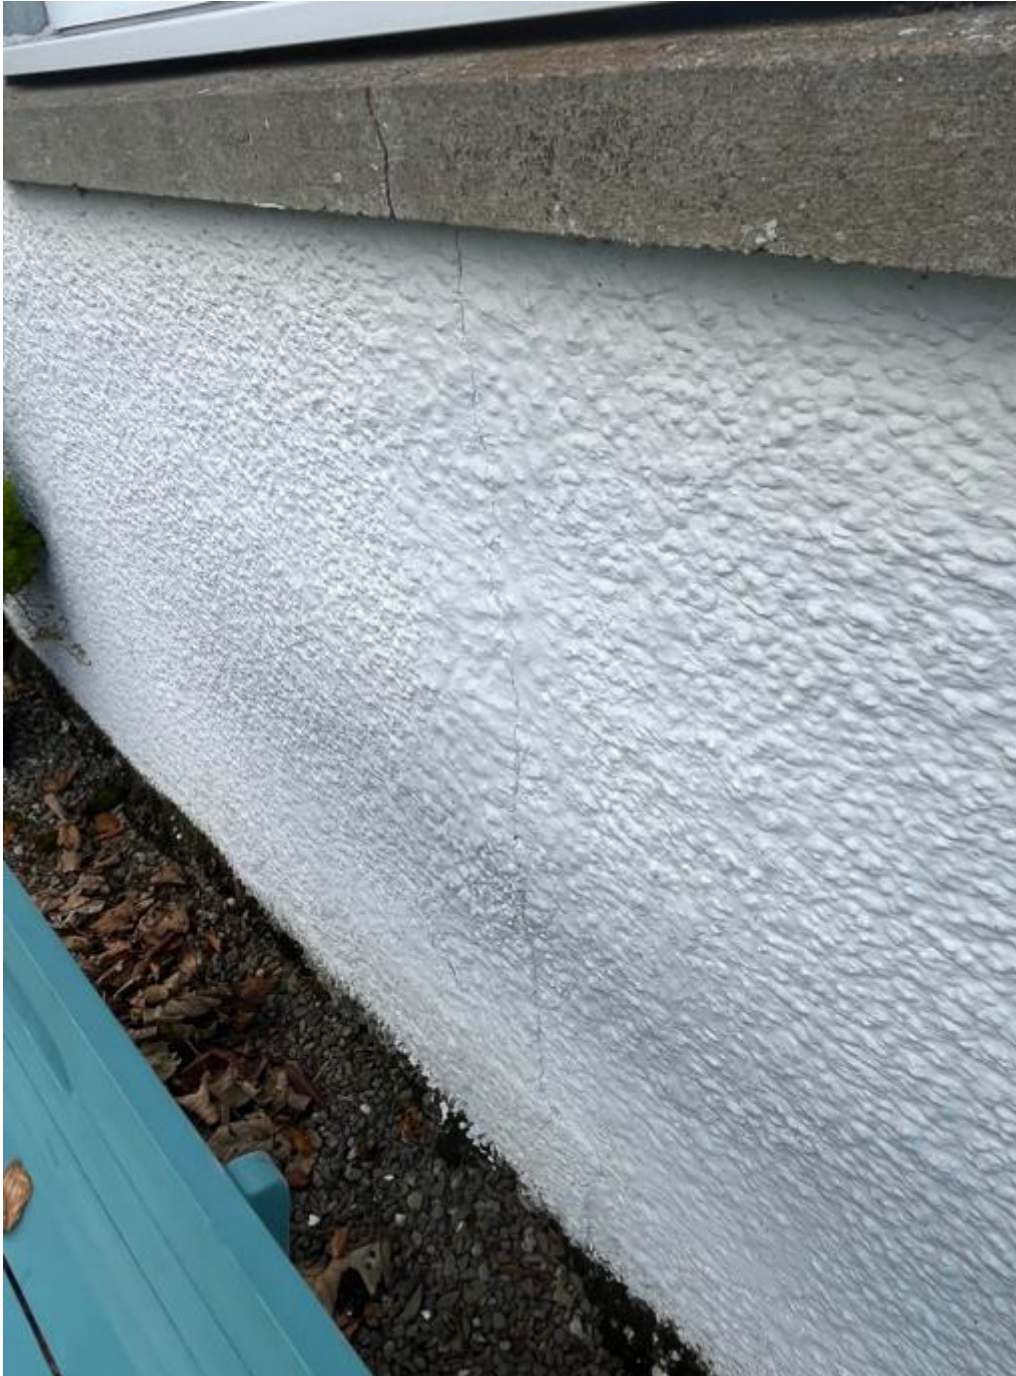
Structural movement	
Repair category:	2
Notes:	<p>The Sitting Room sill and the render to wall is cracked in places.</p> <p>There are trees growing within close proximity of the property.</p> <p>We understand the property was originally of non-traditional PRC (Precast Reinforced Concrete) construction which has subsequently had an outer leaf of blockwork constructed externally and in the current owners time has had the internal PRC construction removed and an internal timber frame constructed.</p> <p>We understand a Structural Inspection has been carried out by Allen Gordon LLP on 2nd December 2024. We would recommend a copy of this report be retained.</p>

Photo 1 - Crack below window

At present we believe the house is competent and structurally sound. We would recommend that the external crack, as a minimum, should be sealed with a flexible mastic to avoid water ingress and further degradation. We would recommend periodic inspections of the roofs, particularly the flat roof area, to ensure that roof coverings are performing adequately.

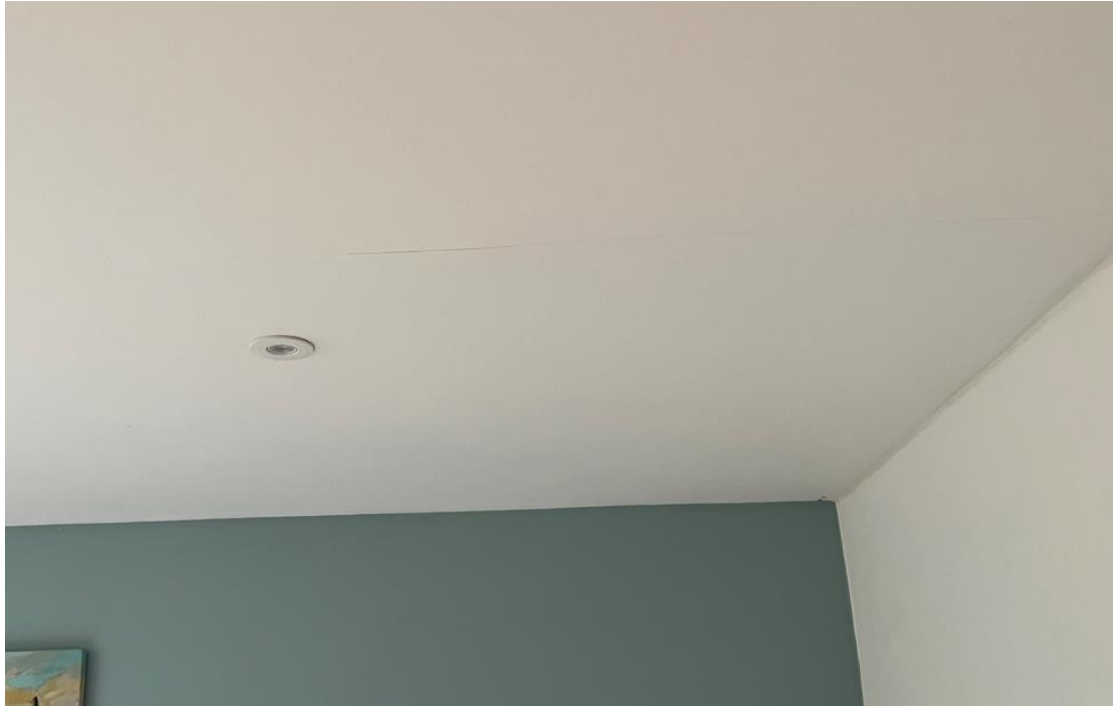
Photo 2 - Crack in ceiling

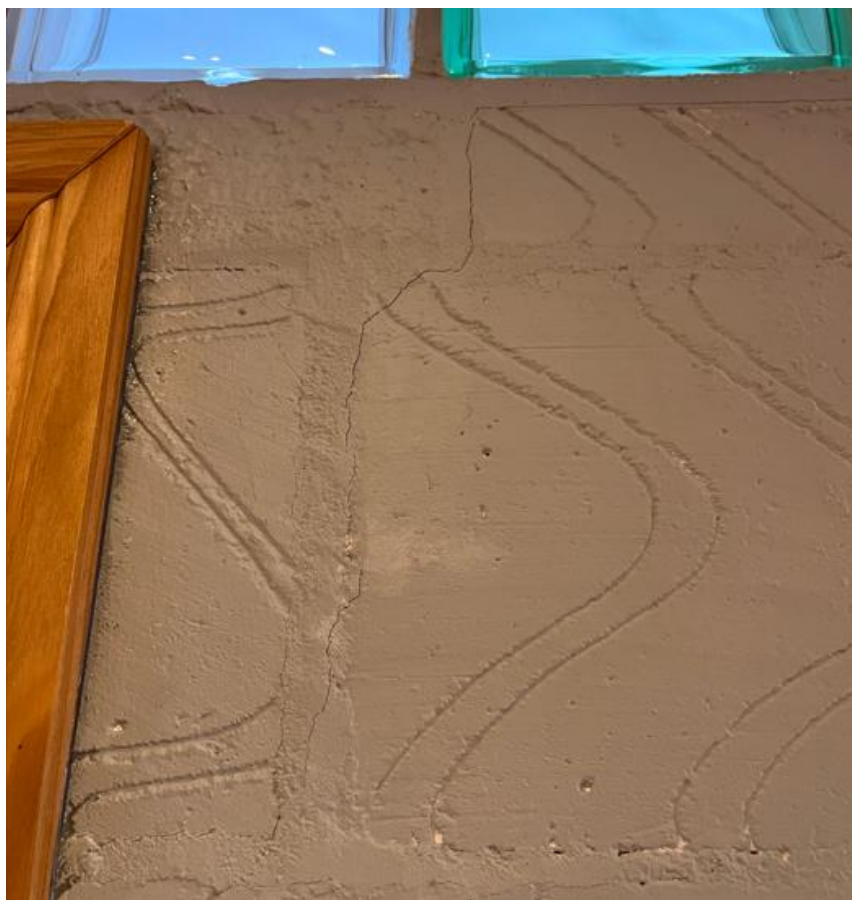
Photo 3 - Cracks in hall / bathroom wall

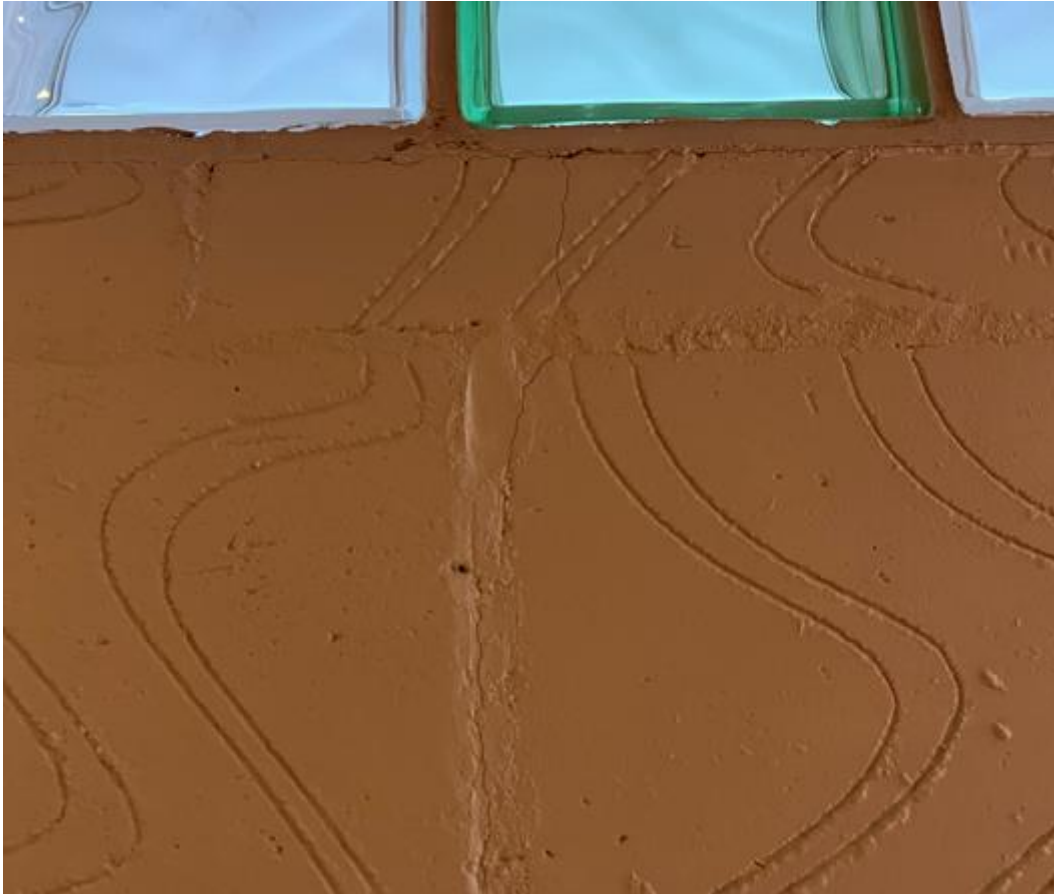
Photo 4 - Cracks in hall / bathroom wall

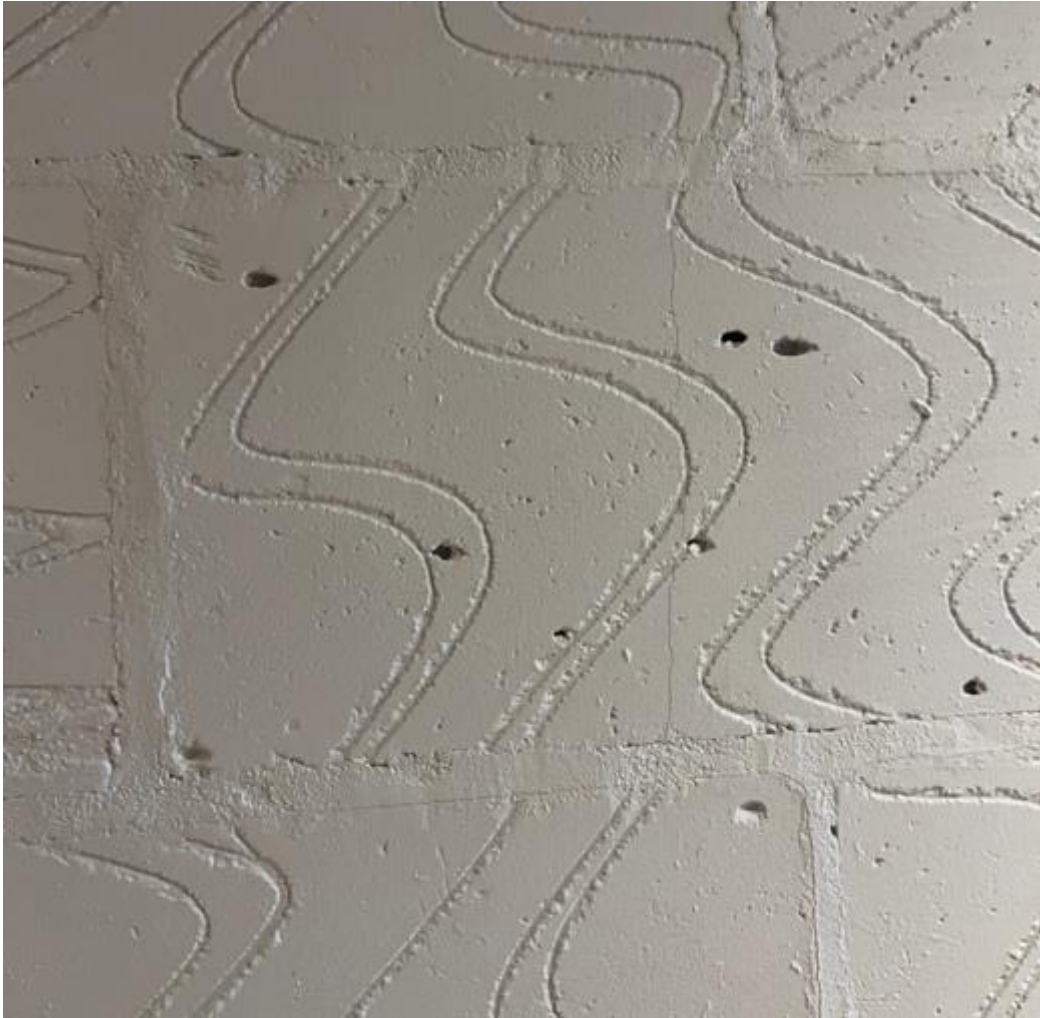
Photo 5 - Cracks in hall / bathroom wall
