YOUR ONESURVEY
HOME REPORT

18 North Erradale
Gairloch
IV21 2DS

SINGLE SURVEY

Surveyor Reference	I/24/07/099
Customer	Mr. Barry Dijkstra
Selling address	18 North Erradale Gairloch IV21 2DS
Date of Inspection	23/07/2024
Prepared by	James Burns, BSc MRICS Inverness - Allied Surveyors Scotland Ltd

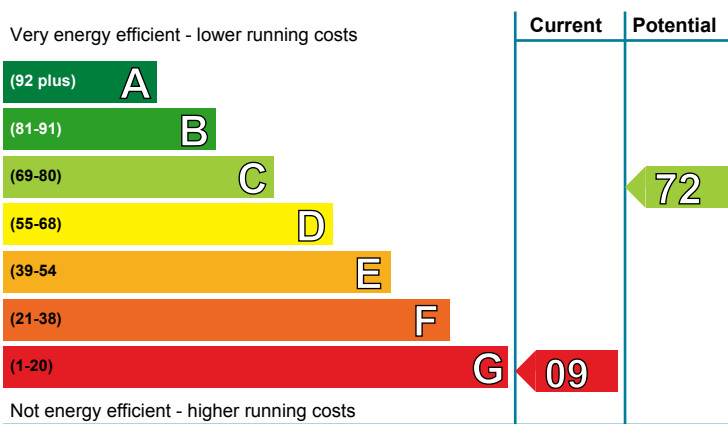
Energy Efficiency Rating

This graph shows the current efficiency of your home, taking into account both energy efficiency and fuel costs. The higher this rating, the lower your fuel bills are likely to be.

Your current rating is **band G (9)**. The average rating for EPCs in Scotland is **band D (61)**.

The potential rating shows the effect of undertaking all of the improvement measures listed within your recommendations report.

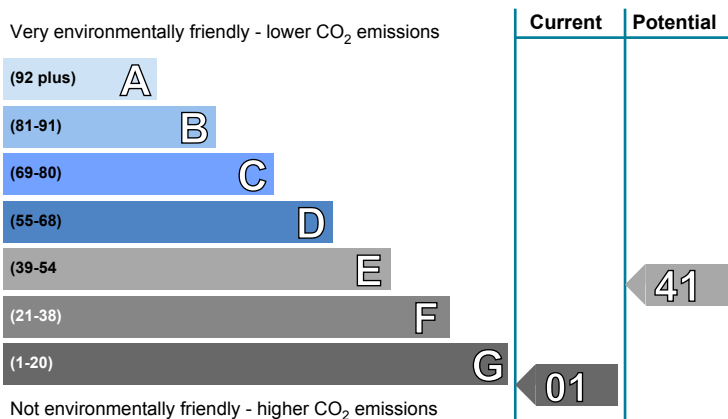
Environmental Impact (CO₂) Rating

This graph shows the effect of your home on the environment in terms of carbon dioxide (CO₂) emissions. The higher the rating, the less impact it has on the environment.
