HOME REPORT

GREENACRES

NAVIDALE
HELMSDALE
KW8 6JS

Single Survey

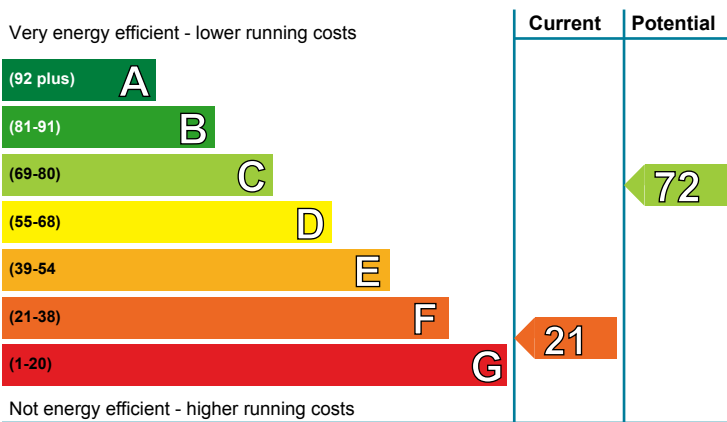
Energy Efficiency Rating

This graph shows the current efficiency of your home, taking into account both energy efficiency and fuel costs. The higher this rating, the lower your fuel bills are likely to be.

Your current rating is **band F (21)**. The average rating for EPCs in Scotland is **band D (61)**.

The potential rating shows the effect of undertaking all of the improvement measures listed within your recommendations report.

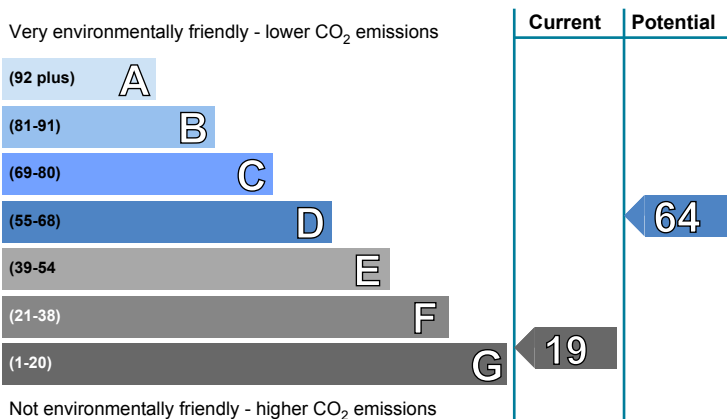
Environmental Impact (CO₂) Rating

This graph shows the effect of your home on the environment in terms of carbon dioxide (CO₂) emissions. The higher the rating, the less impact it has on the environment.

Your current rating is **band G (19)**. The average rating for EPCs in Scotland is **band D (59)**.

The potential rating shows the effect of undertaking all of the improvement measures listed within your recommendations report.
