HOME REPORT

WAITSIDE CASTLETOWN

THURSO
KW14 8SL

Energy Performance Certificate (EPC)

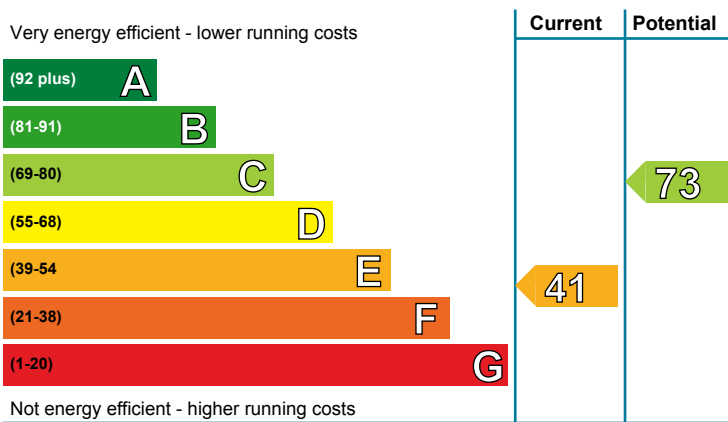
Energy Efficiency Rating

This graph shows the current efficiency of your home, taking into account both energy efficiency and fuel costs. The higher this rating, the lower your fuel bills are likely to be.

Your current rating is **band E (41)**. The average rating for EPCs in Scotland is **band D (61)**.

The potential rating shows the effect of undertaking all of the improvement measures listed within your recommendations report.

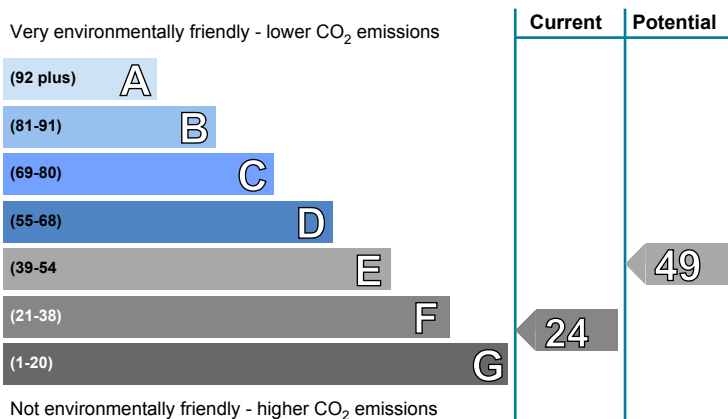
Environmental Impact (CO₂) Rating

This graph shows the effect of your home on the environment in terms of carbon dioxide (CO₂) emissions. The higher the rating, the less impact it has on the environment.

Your current rating is **band F (24)**. The average rating for EPCs in Scotland is **band D (59)**.

The potential rating shows the effect of undertaking all of the improvement measures listed within your recommendations report.
