HOME REPORT

3 ROBERTSON SQUARE
WICK
KW1 5NF

Energy Performance Certificate (EPC)

3 ROBERTSON SQUARE, WICK, KW1 5NF

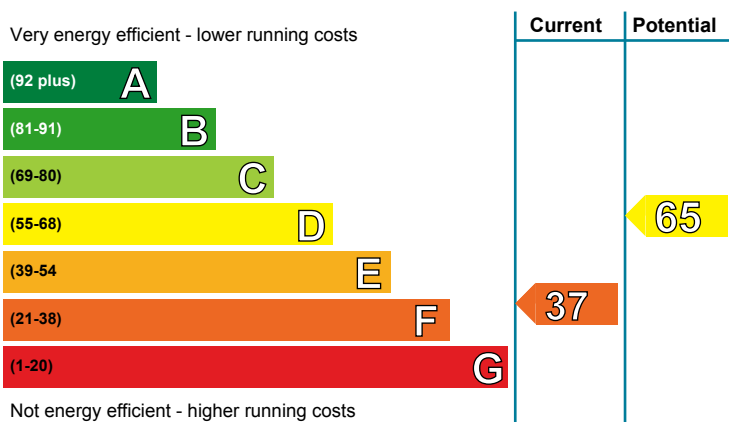
Energy Efficiency Rating

This graph shows the current efficiency of your home, taking into account both energy efficiency and fuel costs. The higher this rating, the lower your fuel bills are likely to be.

Your current rating is **band F (37)**. The average rating for EPCs in Scotland is **band D (61)**.

The potential rating shows the effect of undertaking all of the improvement measures listed within your recommendations report.

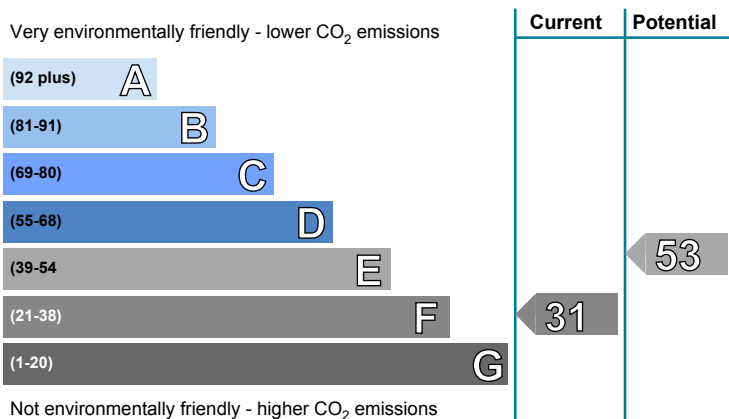
Environmental Impact (CO₂) Rating

This graph shows the effect of your home on the environment in terms of carbon dioxide (CO₂) emissions. The higher the rating, the less impact it has on the environment.

Your current rating is **band F (31)**. The average rating for EPCs in Scotland is **band D (59)**.

The potential rating shows the effect of undertaking all of the improvement measures listed within your recommendations report.
