YOUR ONESURVEY HOME REPORT

30 Cornwell Crescent Fortrose IV10 8AB

Single Survey

Date of Inspection	26/08/2024
Prepared by	James Burns, BSc MRICS
	Inverness - Allied Surveyors Scotland Ltd

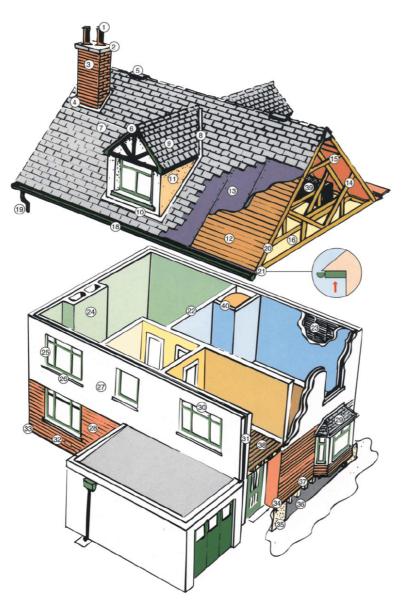
Sectional Diagram showing elements of a typical house

Reference may be made in this report to some or all of the above component parts of the property. This diagram may assist you in locating and understanding these items.
