YOUR ONESURVEY
HOME REPORT

Mildon
Lybster, Caithness
KW3 6BT

SINGLE SURVEY

Surveyor Reference	I/24/07/136
Executry Of	Mr. William John Williams
Selling address	Mildon Lybster, Caithness KW3 6BT
Date of Inspection	31/07/2024
Prepared by	Lauren Dryburgh, BSc MRICS Inverness - Allied Surveyors Scotland Ltd

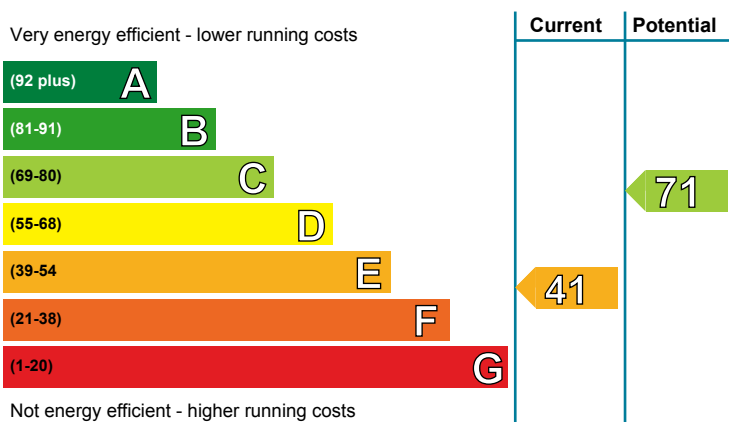
Energy Efficiency Rating

This graph shows the current efficiency of your home, taking into account both energy efficiency and fuel costs. The higher this rating, the lower your fuel bills are likely to be.

Your current rating is **band E (41)**. The average rating for EPCs in Scotland is **band D (61)**.

The potential rating shows the effect of undertaking all of the improvement measures listed within your recommendations report.

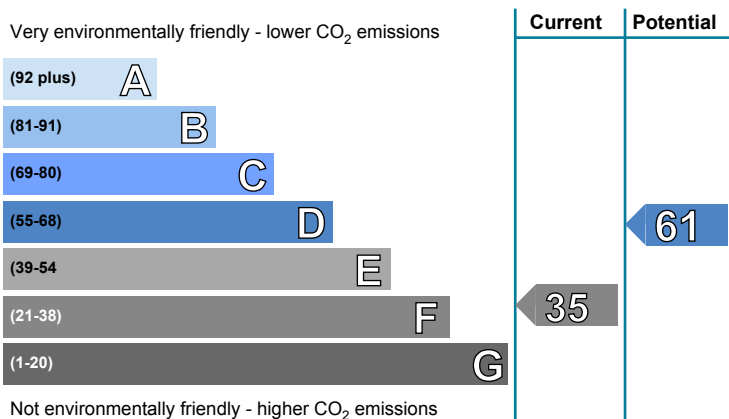
Environmental Impact (CO₂) Rating

This graph shows the effect of your home on the environment in terms of carbon dioxide (CO₂) emissions. The higher the rating, the less impact it has on the environment.
