HOME
report

SINGLE SURVEY
ENERGY REPORT
PROPERTY QUESTIONNAIRE
VALUATION REPORT

Survey report on:

Property Address	2 Laurel Bank Dingwall IV15 9NE
Customer	Ms K Windle
Date of Inspection	02/08/2024
Prepared by	Douglas J H Mowat Harvey Donaldson & Gibson Chartered Surveyors

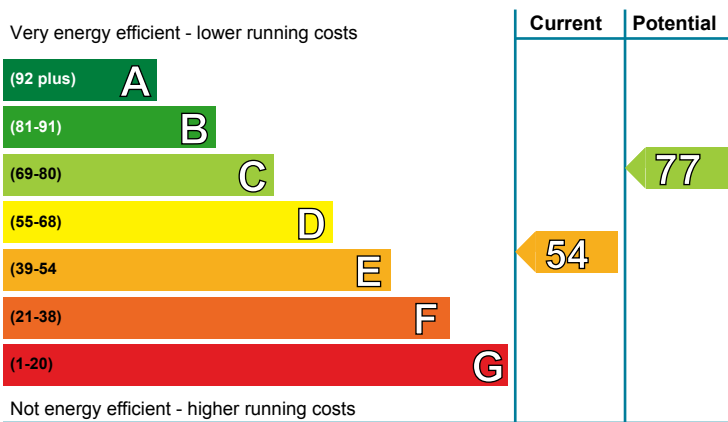
Energy Efficiency Rating

This graph shows the current efficiency of your home, taking into account both energy efficiency and fuel costs. The higher this rating, the lower your fuel bills are likely to be.

Your current rating is **band E (54)**. The average rating for EPCs in Scotland is **band D (61)**.

The potential rating shows the effect of undertaking all of the improvement measures listed within your recommendations report.

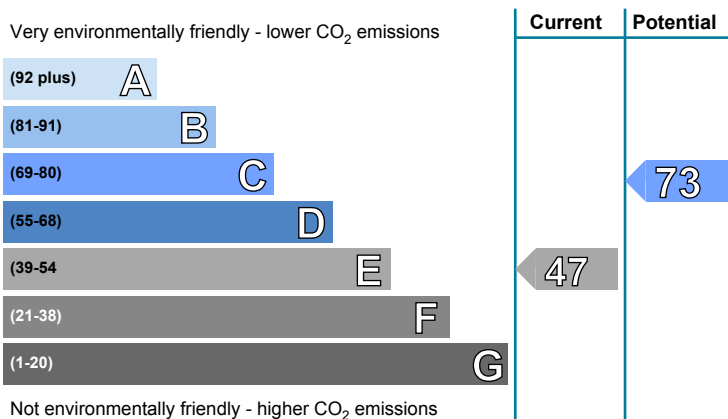
Environmental Impact (CO₂) Rating

This graph shows the effect of your home on the environment in terms of carbon dioxide (CO₂) emissions. The higher the rating, the less impact it has on the environment.
