HOME REPORT

25 LOCH STREET
WICK
KW1 5QL

Energy Performance Certificate (EPC)

25 LOCH STREET, WICK, KW1 5QL

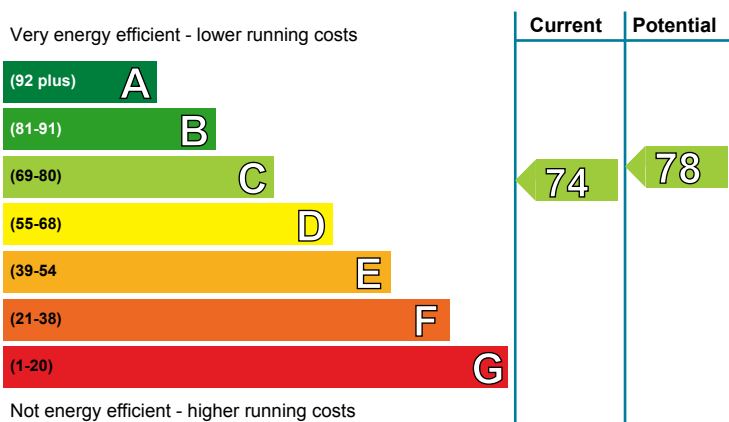
Energy Efficiency Rating

This graph shows the current efficiency of your home, taking into account both energy efficiency and fuel costs. The higher this rating, the lower your fuel bills are likely to be.

Your current rating is **band C (74)**. The average rating for EPCs in Scotland is **band D (61)**.

The potential rating shows the effect of undertaking all of the improvement measures listed within your recommendations report.

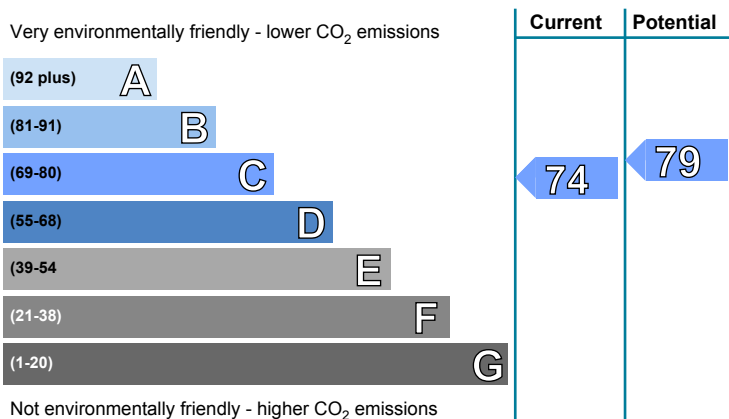
Environmental Impact (CO₂) Rating

This graph shows the effect of your home on the environment in terms of carbon dioxide (CO₂) emissions. The higher the rating, the less impact it has on the environment.

Your current rating is **band C (74)**. The average rating for EPCs in Scotland is **band D (59)**.

The potential rating shows the effect of undertaking all of the improvement measures listed within your recommendations report.
