HOME REPORT

MILTON HOUSE MAIN STREET

LYBSTER
KW3 6AQ

Energy Performance Certificate (EPC)

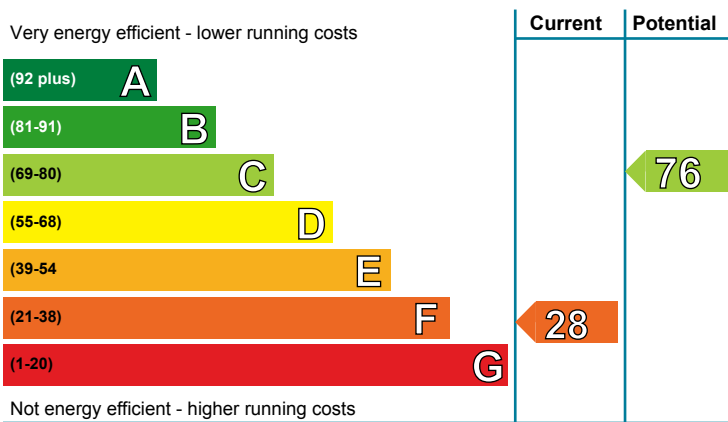
Energy Efficiency Rating

This graph shows the current efficiency of your home, taking into account both energy efficiency and fuel costs. The higher this rating, the lower your fuel bills are likely to be.

Your current rating is **band F (28)**. The average rating for EPCs in Scotland is **band D (61)**.

The potential rating shows the effect of undertaking all of the improvement measures listed within your recommendations report.

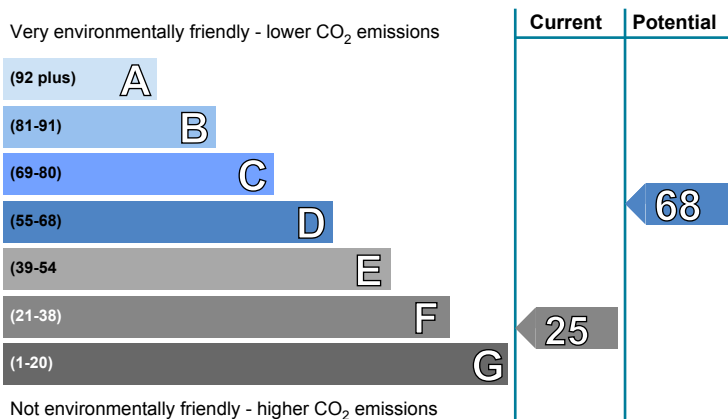
Environmental Impact (CO₂) Rating

This graph shows the effect of your home on the environment in terms of carbon dioxide (CO₂) emissions. The higher the rating, the less impact it has on the environment.

Your current rating is **band F (25)**. The average rating for EPCs in Scotland is **band D (59)**.

The potential rating shows the effect of undertaking all of the improvement measures listed within your recommendations report.
