# **HOME REPORT**

#### **MORVEN VIEW LYTH**

**WICK KW1 4UF**

# SINGLE SURVEY

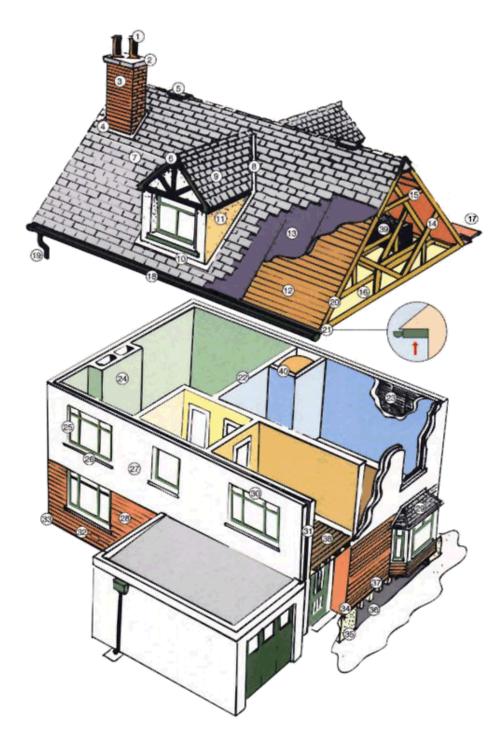
#### Sectional Diagram showing elements of a typical house

Reference may be made in this report to some or all of the above component parts of the property. This diagram may assist you in locating and understanding these items.

- 1) Chimney pots
- 2) Coping stone
- 3) Chimney head
- 4 Flashing
- 5) Ridge ventilation
- 6) Ridge board
- 7) Slates / tiles
- 8 Valley guttering
- 9 Dormer projection
- 10) Dormer flashing
- 11) Dormer cheeks
- (12) Sarking
- (13) Roof felt
- (14) Trusses
- (15) Collar
- 16) Insulation
- 17) Parapet gutter
- (18) Eaves guttering
- 19) Rainwater downpipe
- 20) Verge boards/skews
- 21) Soffit boards
- 22) Partition wall
- 23) Lath / plaster
- 24) Chimney breast
- (25) Window pointing
- 6) Window sills
- 27) Rendering
- (28) Brickwork / pointing
- 29) Bay window projection
- 30 Lintels
- (31) Cavity walls / wall ties
- 32) Subfloor ventilator
- 33 Damp proof course
- 34) Base course
- 35) Foundations
- (36) Solum
- 37) Floor joists
- 38) Floorboards
- 39) Water tank
- 40) Hot water tank
