YOUR ONESURVEY  
**HOME REPORT**

23 Castlehill Gardens  
Inverness  
IV2 5DJ

# SINGLE SURVEY

A report on the condition of the property, with categories being rated from 1 to 3.

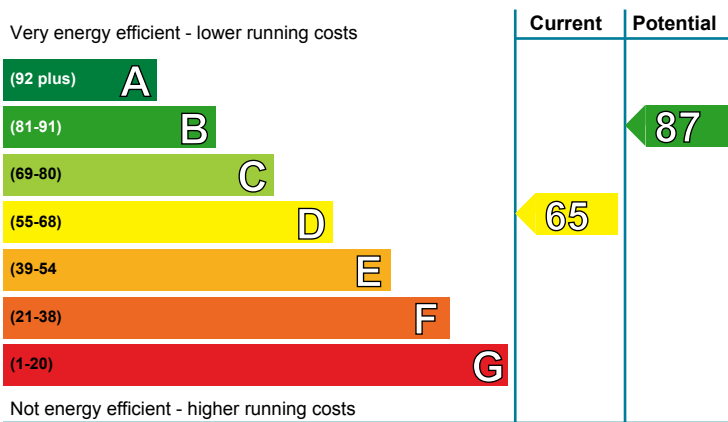
## Energy Efficiency Rating

This graph shows the current efficiency of your home, taking into account both energy efficiency and fuel costs. The higher this rating, the lower your fuel bills are likely to be.

Your current rating is **band D (65)**. The average rating for EPCs in Scotland is **band D (61)**.

The potential rating shows the effect of undertaking all of the improvement measures listed within your recommendations report.

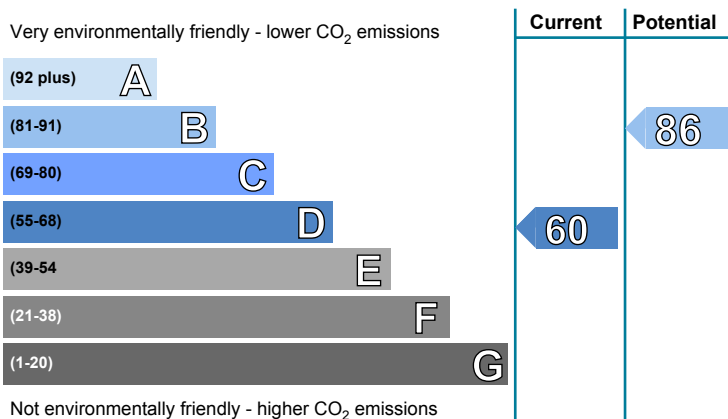
## Environmental Impact (CO<sub>2</sub>) Rating

This graph shows the effect of your home on the environment in terms of carbon dioxide (CO<sub>2</sub>) emissions. The higher the rating, the less impact it has on the environment.
