# Home Report

76 Diriebught Road  
Inverness IV2 3QN

# Single Survey

<b>Property Address</b>	76 Diriebught Road Inverness IV2 3QN
<b>Customer</b>	Alison Donald
<b>Prepared by</b>	Graham + Sibbald LLP
<b>Date of Inspection</b>	26/03/2025

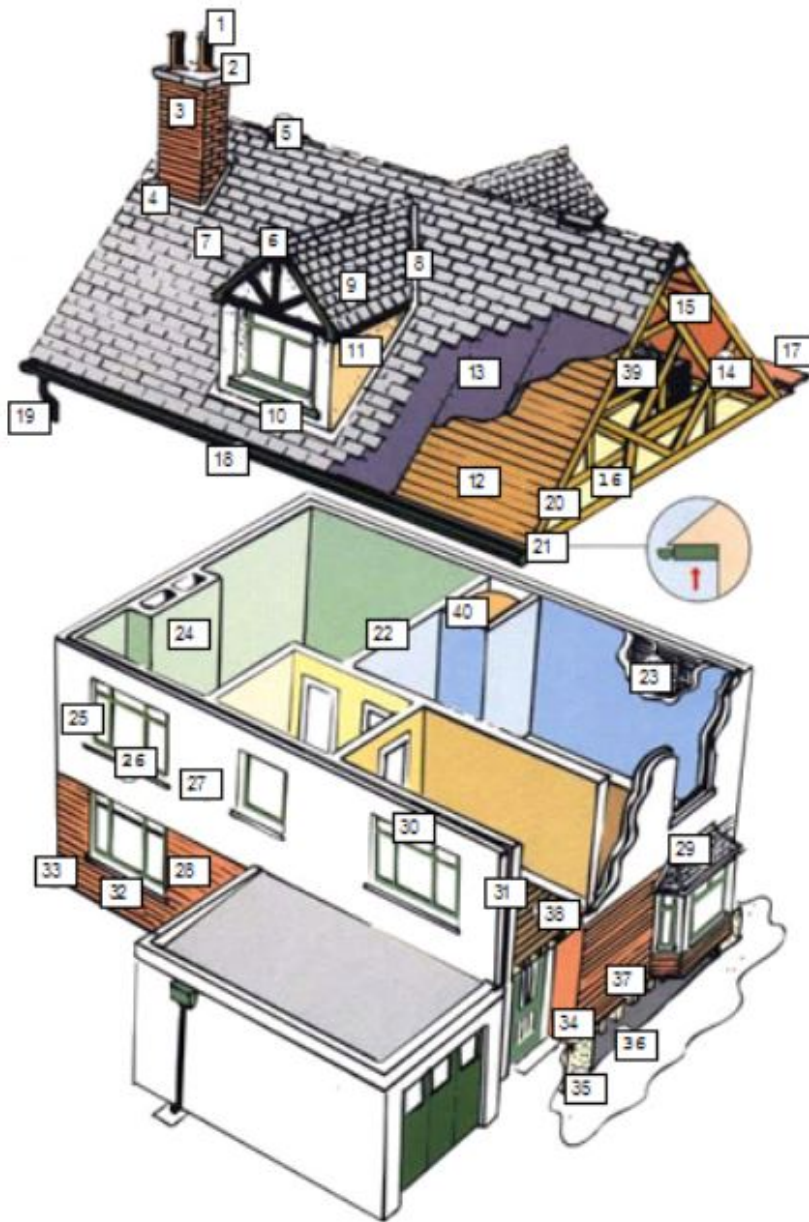
## Sectional diagram showing elements of a typical house

1	Chimney pots
2	Coping stone
3	Chimney head
4	Flashing
5	Ridge ventilation
6	Ridge board
7	Slates / tiles
8	Valley guttering
9	Dormer projection
10	Dormer flashing
11	Dormer cheeks
12	Sarking
13	Roof felt
14	Trusses
15	Collar
16	Insulation
17	Parapet gutter
18	Eaves guttering
19	Rainwater downpipe
20	Verge boards / skews
21	Soffit boards
22	Partition wall
23	Lath / plaster
24	Chimney breast
25	Window pointing
26	Window sills
27	Rendering
28	Brickwork / pointing
29	Bay window projection
30	Lintels
31	Cavity walls / wall ties
32	Subfloor ventilator
33	Damp proof course
34	Base course
35	Foundations
36	Solum
37	Floor joists
38	Floorboards
39	Water tank
40	Hot water tank

Reference may be made in this report to some or all of the above component parts of the property. This diagram may assist you in locating and understanding these items.
